Northern Inspections

Property Inspection Report

Inspection prepared for: WITHHELD NAME
Inspection Date: 9/25/2013 Time: 10:00 AM
Age: 50+ YRS Size: 1000+/- SF
Weather: RAINY/COOL

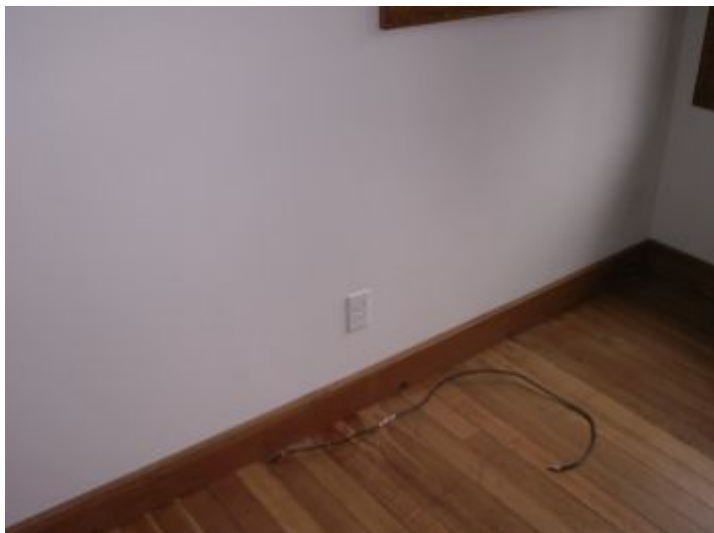
- The majority of grounded receptacles were tested and found to be wired correctly.
- One living room receptacle has an open ground.

Living room outlet with an open ground.

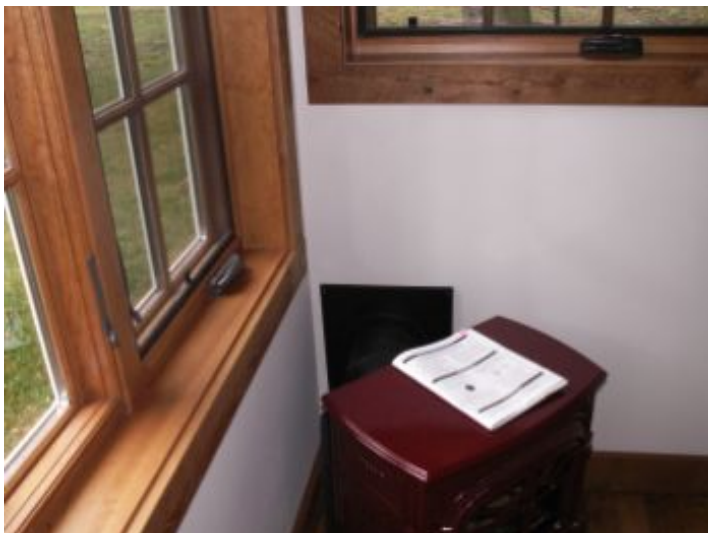
- Living Room gas fireplace ignited and appeared to function normally.
- The gas fireplace exhaust is located directly below an operable window. Does not meet current codes and standards.

Gas exhausts below an operable window. Does not meet current codes and standards.

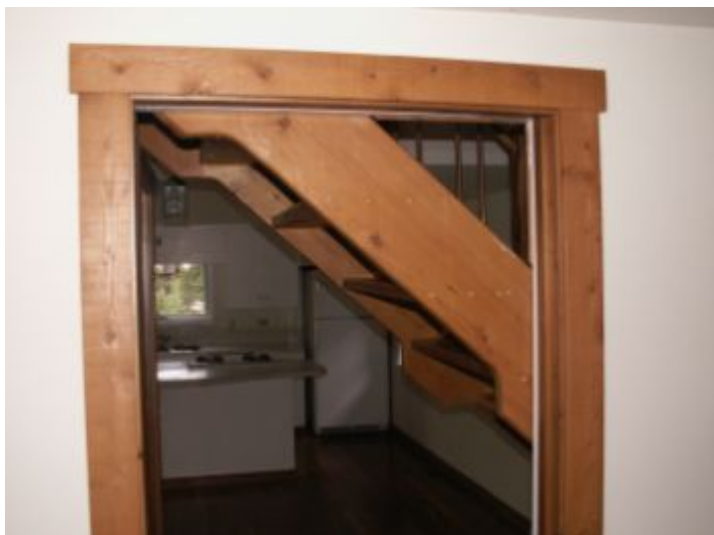
- No deficiencies observed in door. Stairway runs across door opening.

Bedroom door with stairs.

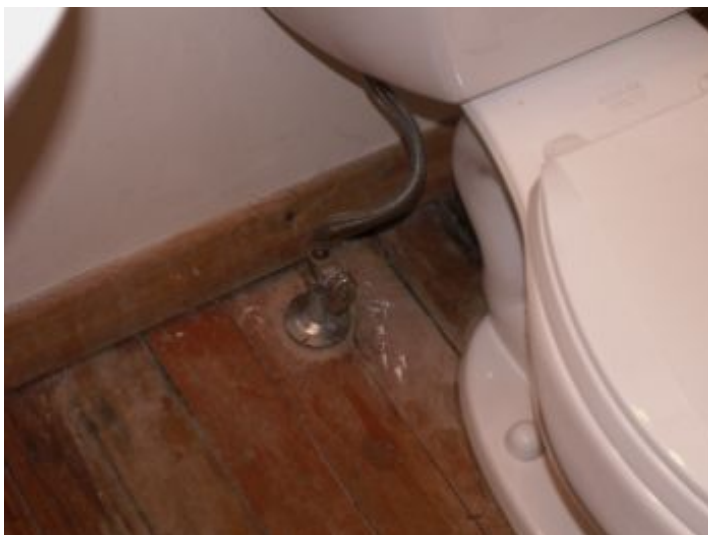
Materials: Hardwood flooring is noted.
Observations:
• No deficiencies observed, however there is evidence of previous leaking around the toilet. Monitor for leaking.

Bathroom floor with evidence of previous leaking. Not leaking currently. Monitor.

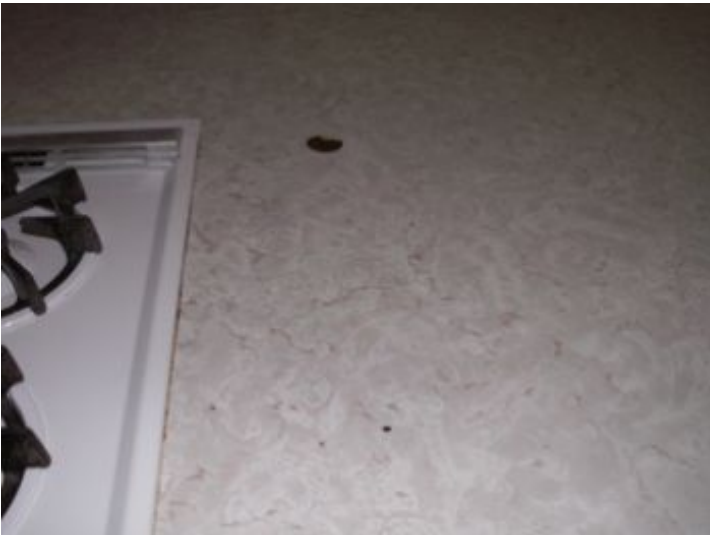
Observations:
 • Laminate tops noted.
 • The island counter top is chipped.

Kitchen island counter with chips.

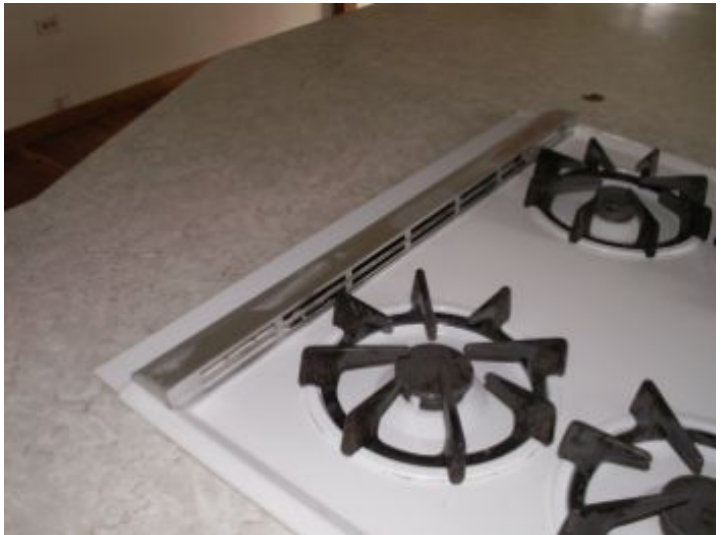
Materials: Recirculating
 Observations:
 • Exhaust fan did not operate.

Range exhaust fan does not operate.

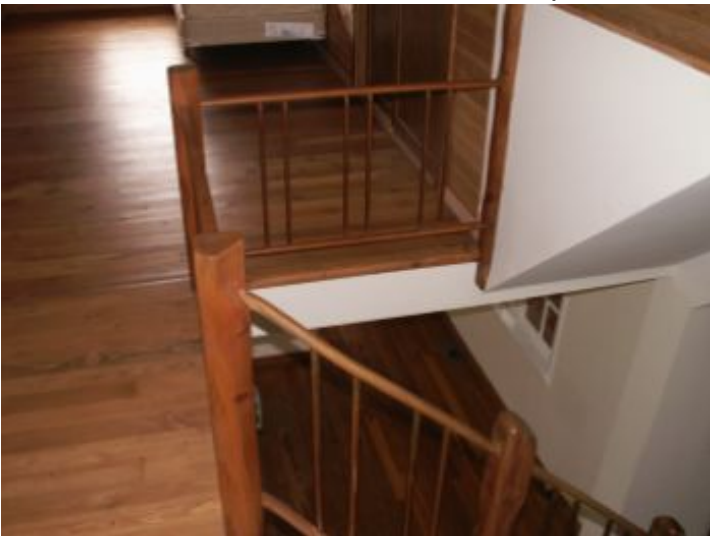
- Stair treads are less than 10 inches.
- Stair railing is 26 inches. Minimum stair railing is 34 inches from nose of tread.

Loft/stair railing at 26 inches. Code minimum is 36 inches for loft and 34 inches on stairs.

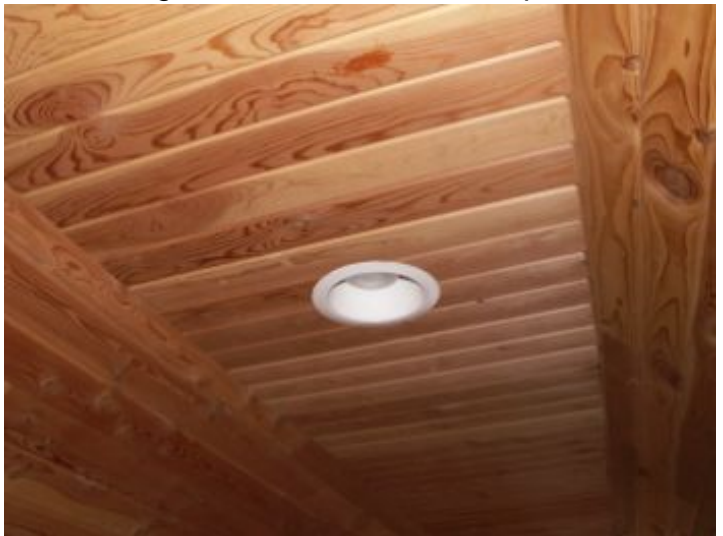
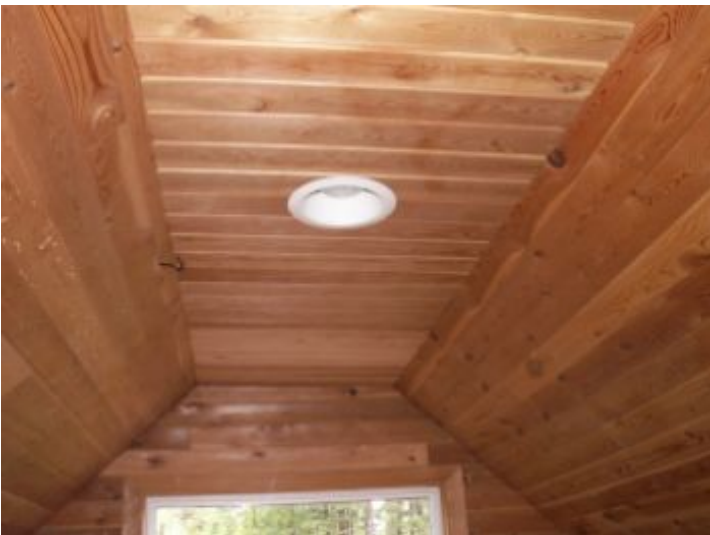
Loft fixture did not operate. Replace bulb and re-check.

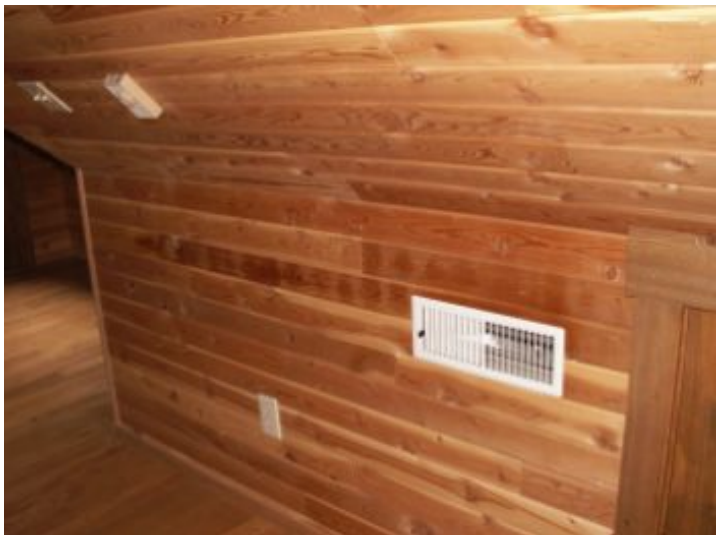
Loft exhaust fan. No deficiencies observed.

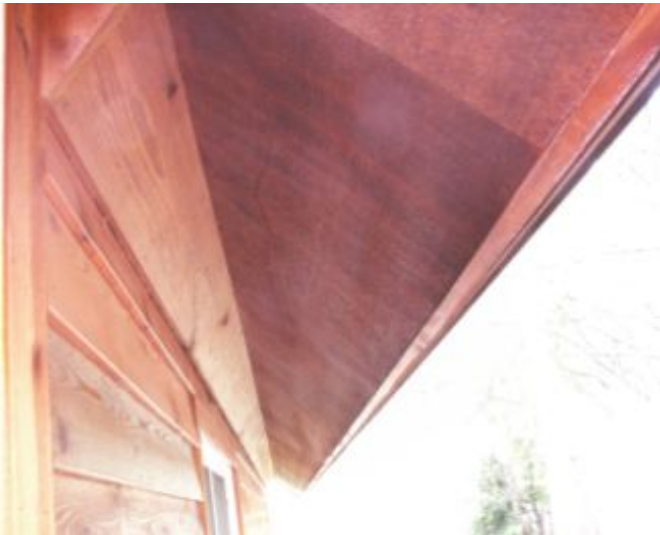
Observations:
• No soffit venting present. It appears that a new roof has been framed over an old roof. If urethane spray foam has been used to insulate the roof, then no soffit venting is needed. If fiberglass insulation was used to insulate the roof, soffit venting would be needed. Insulation method should be verified.

No soffit venting present. May not be needed depending on type of insulation in the roof.

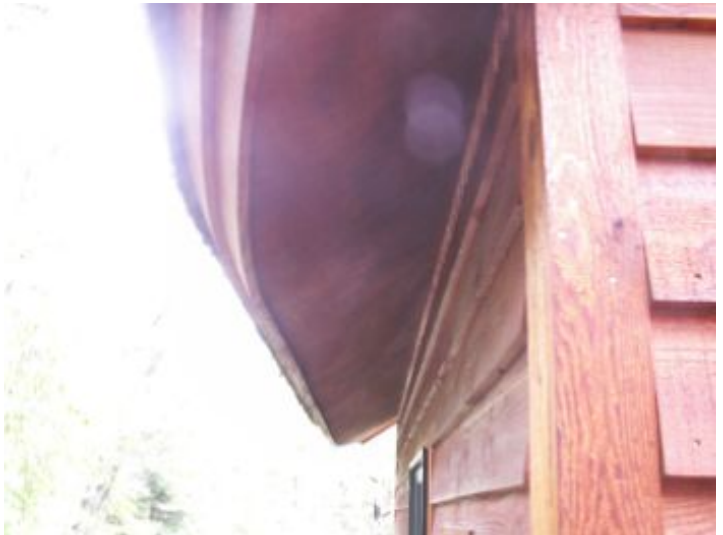
No soffit venting present in the bunkhouse. May not be needed depending on type of insulation.

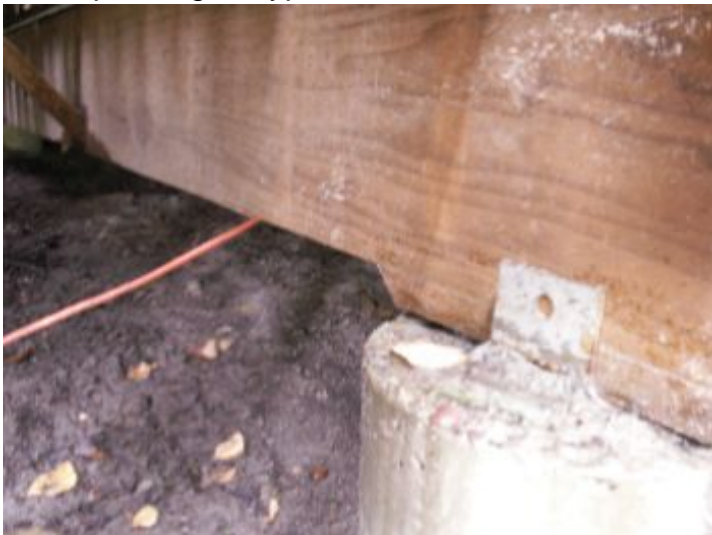
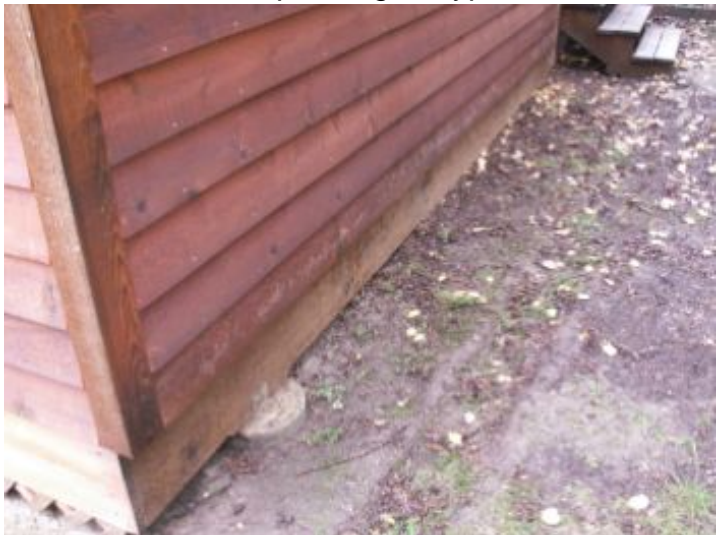
Bunkhouse supported on concrete piers. No deficiencies observed.

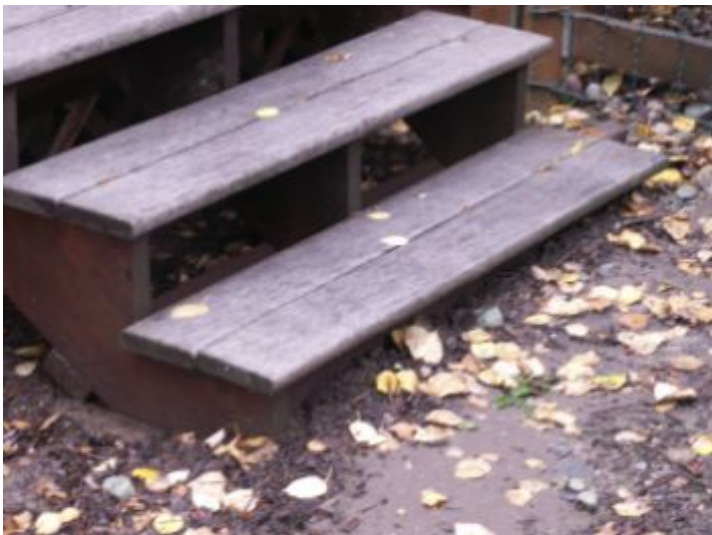
- The rear deck stairs by the bunkhouse are in contact with the dirt. Contact with dirt will accelerate deterioration of the stair framing members.

Stair stringers in contact with dirt. Contact with dirt will accelerate deterioration.

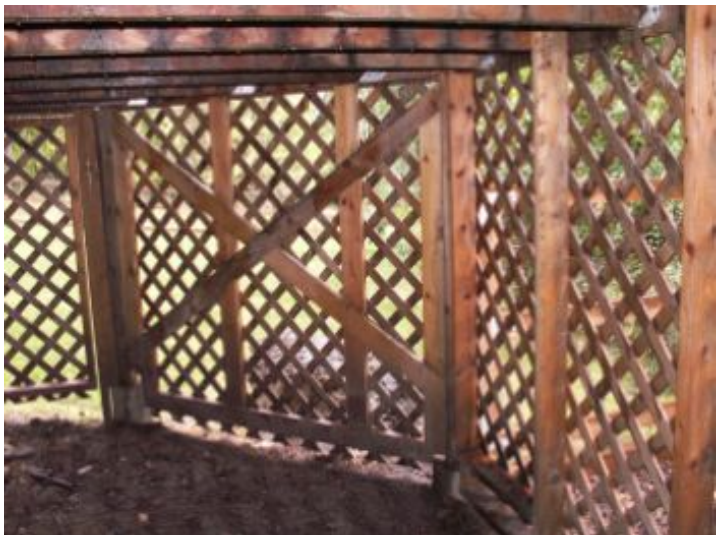
Deck framing. No deficiencies observed.

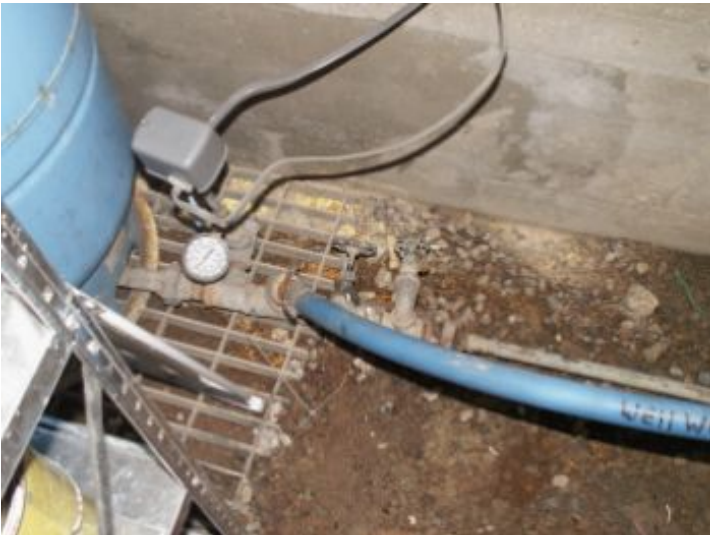
Water shut off for the house. No deficiencies observed.

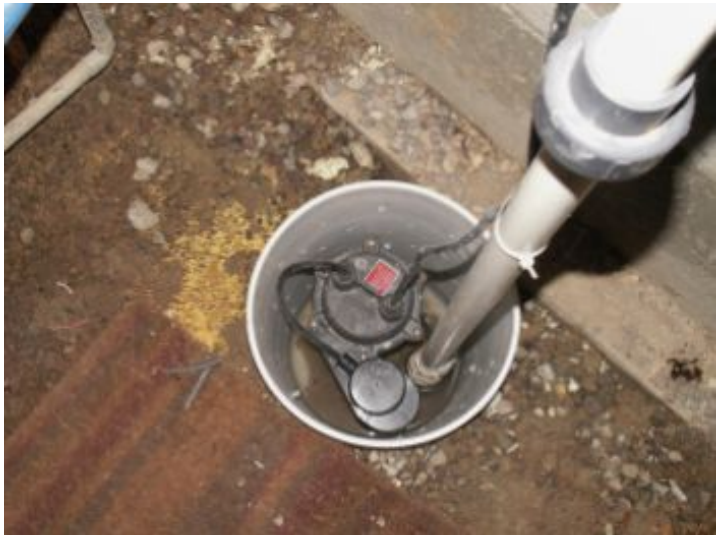
Sump pump in mechanical crawlspace functioning. No deficiencies observed.

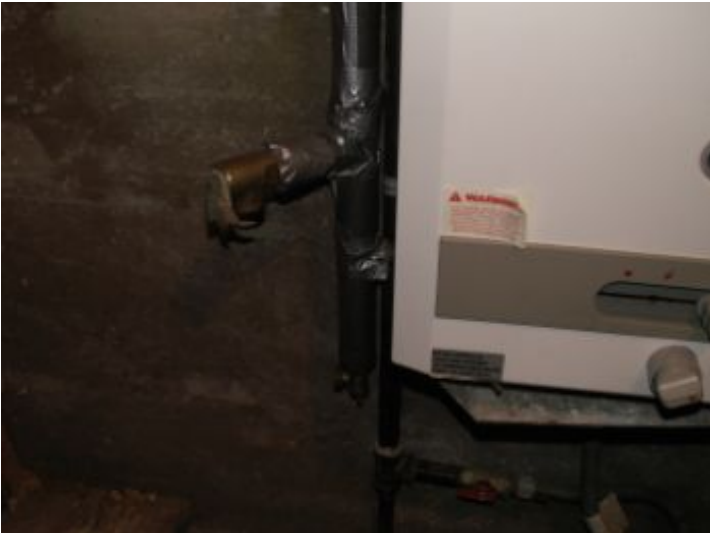
- The TPR valve is not piped to within 6" of the ground.

TPR valve on On Demand Water Heater should be piped to within 6 inches of the ground.

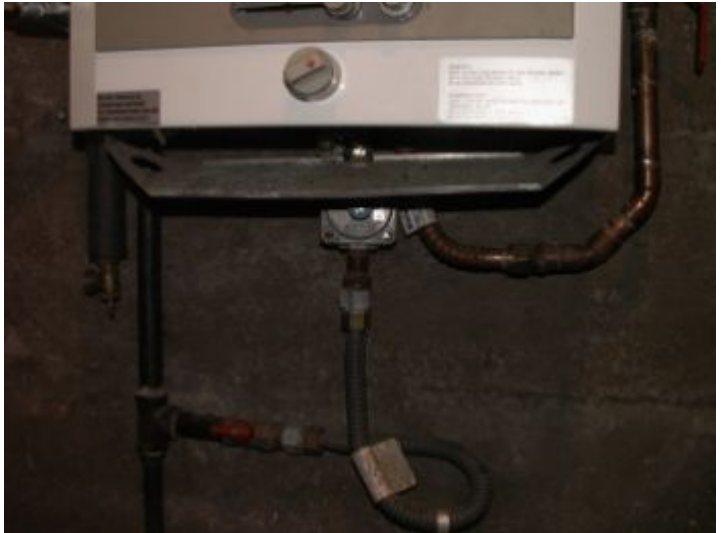
On Demand Water Heater in mechanical crawlspace. No deficiencies observed.

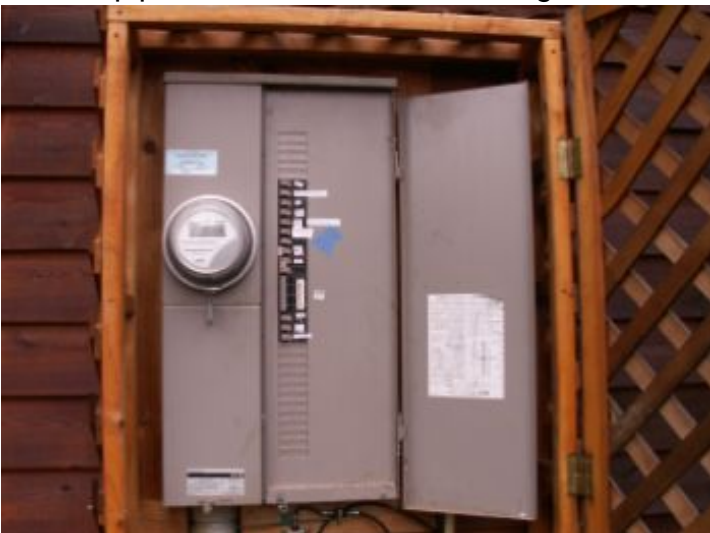
Electrical main and breaker panel. Labeled. No deficiencies observed.

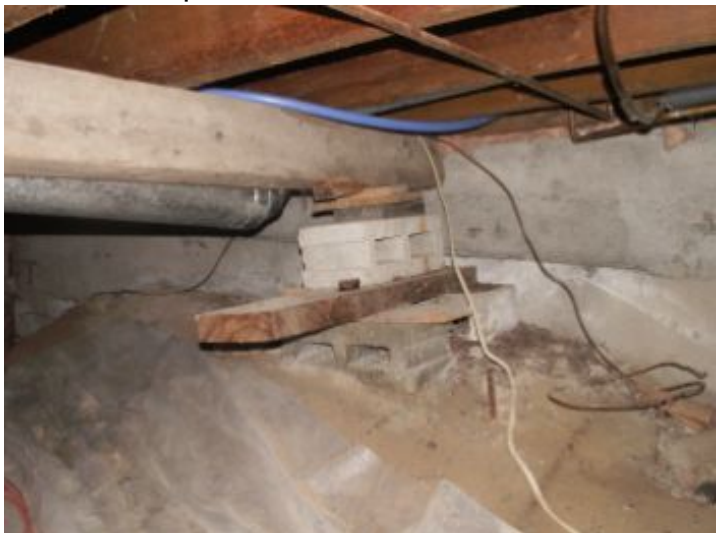
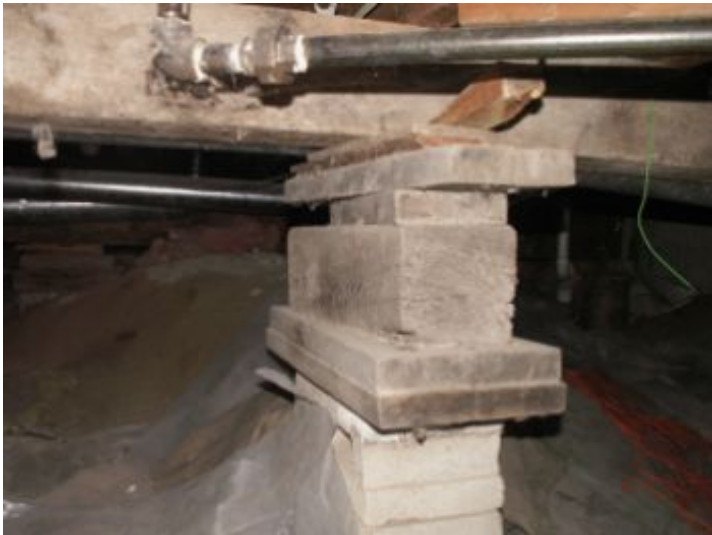
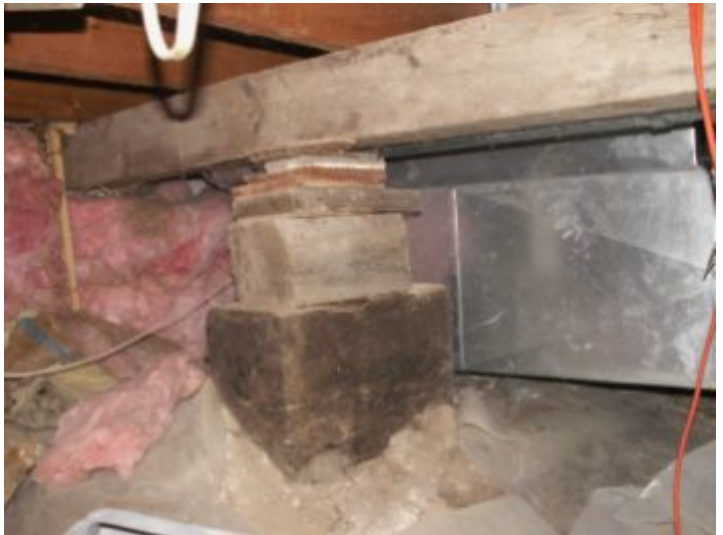
- The floor girders are supported by stacks of wooden blocks. Although the blocks have been in place a long time, suggest replacing with concrete piers and wood/steel posts.

Crawlspace. Girders supported by stacks of wood blocks.

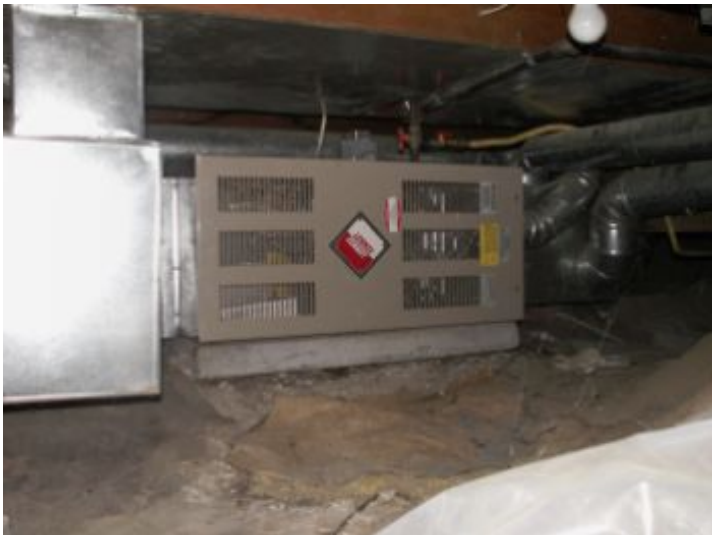
Crawlspace. Gas furnace. No deficiencies observed.

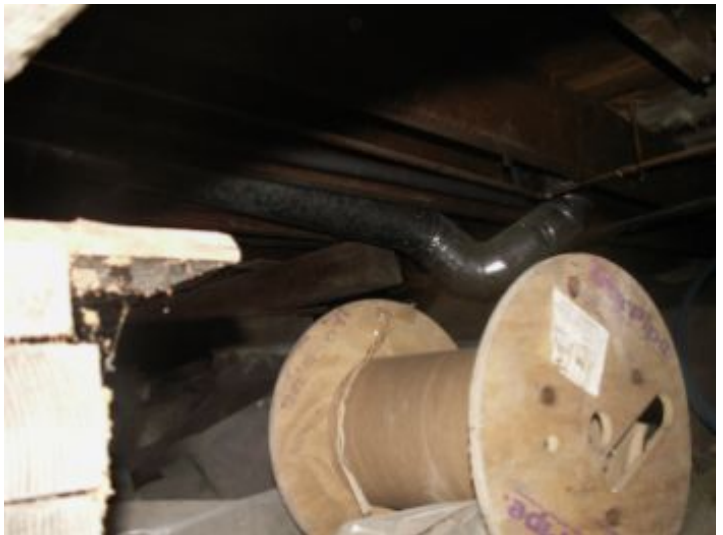
Debris left in crawlspace.

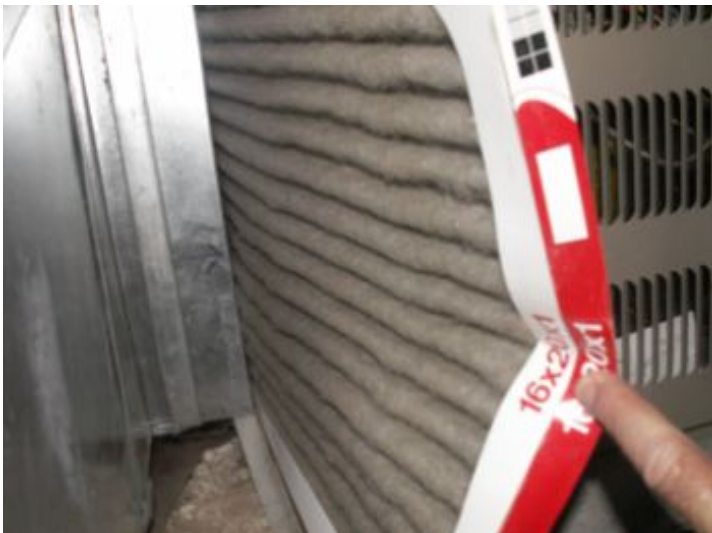
Furnace filter clean.

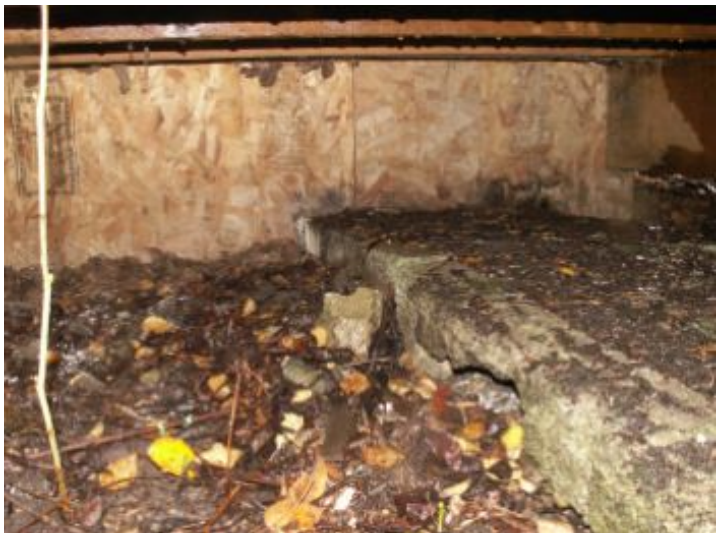
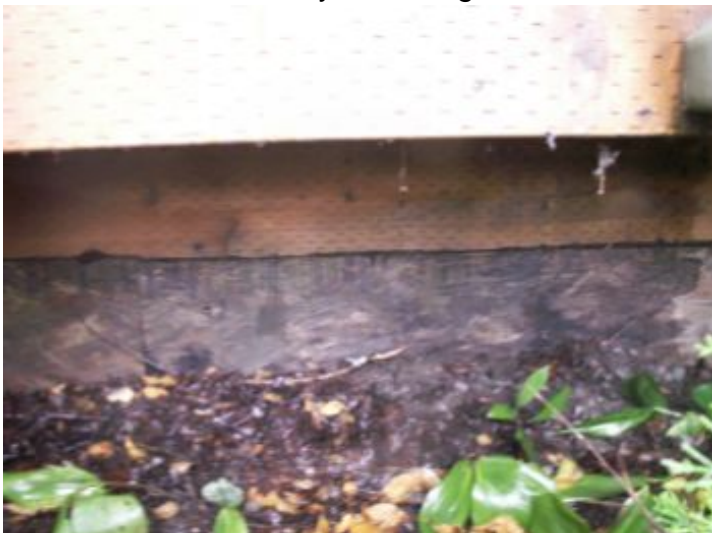
- OSB has been used to seal off the space below the front entry porch. The OSB is in contact with the ground and will rot.

Below deck at front entry. OSB sheathing in contact with ground.

Below front deck. OSB sheathing in contact with the ground.

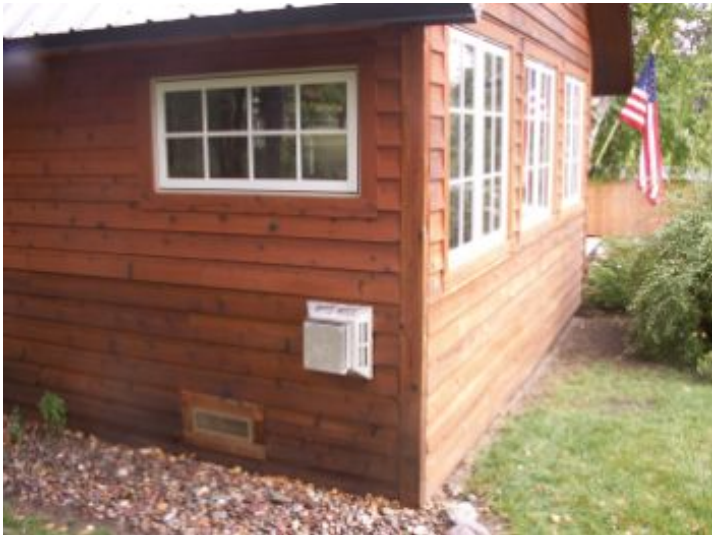
Gas stove exhaust vent below an operable window. Does not meet current codes and standards.

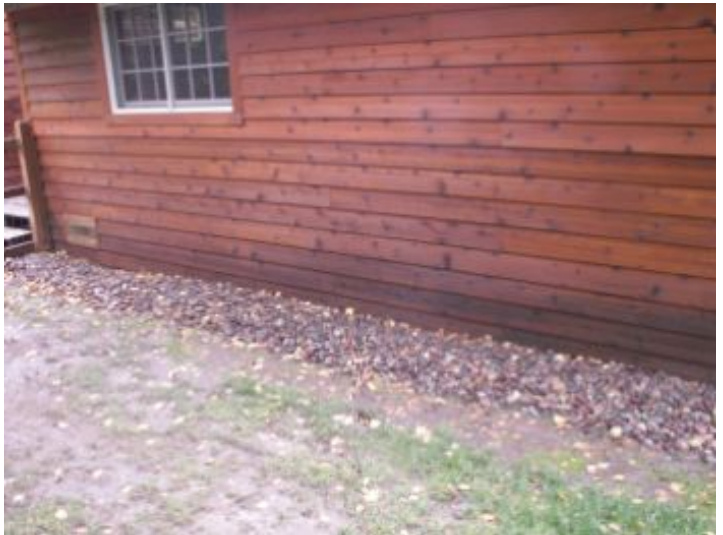
- The exterior drainage is generally away from foundation except on the west side. West side has washed gravel adjacent to the house to prevent splashing on to the siding. West side grade slopes toward the foundation.

Grade on west side of house is sloped toward the house. Gravel is used to prevent mud splashing on to siding.

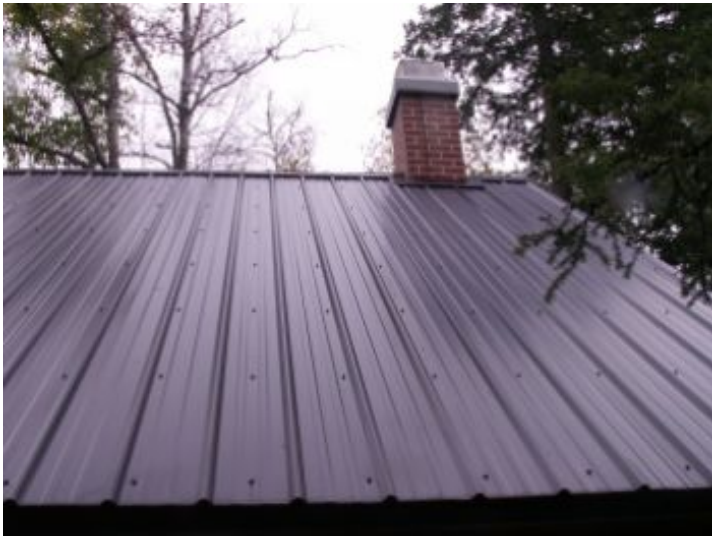
Old chimney not being used,

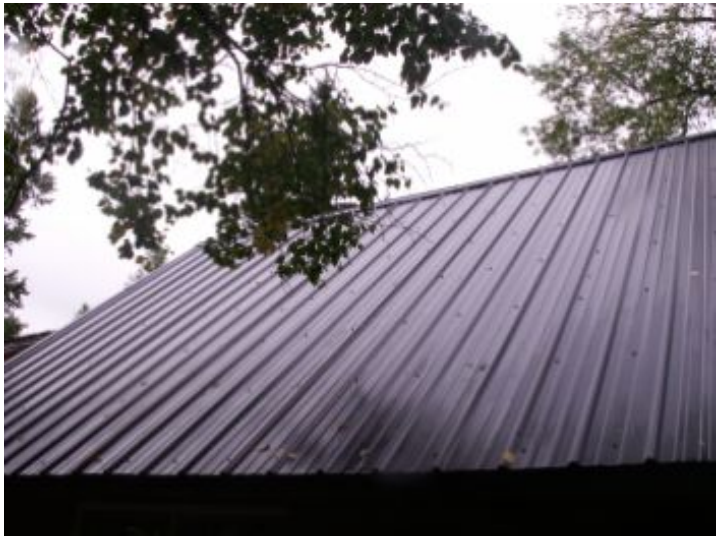
Metal roofing. No deficiencies observed.

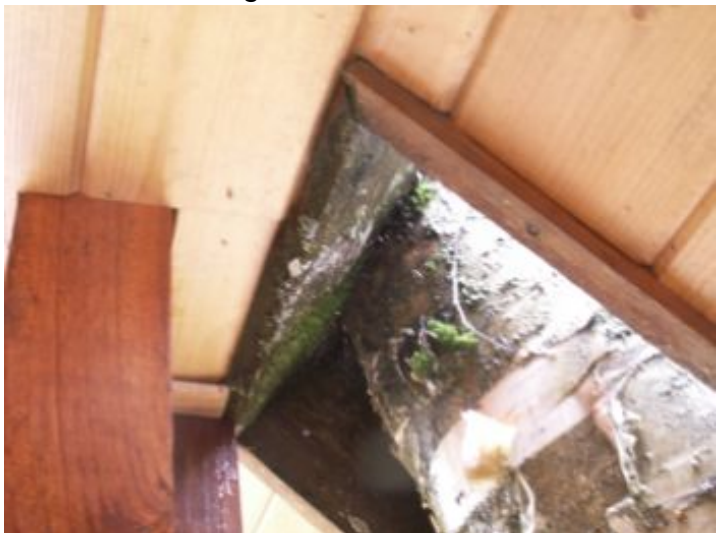
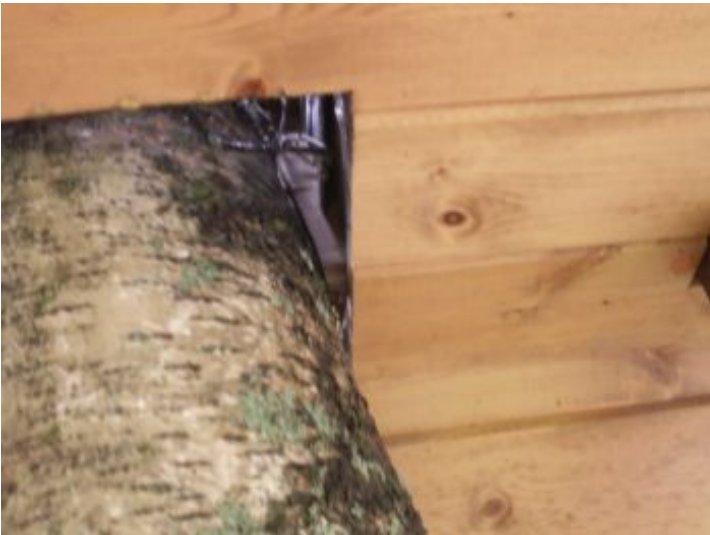
- Birch trees at the front porch are in contact with the porch roof. Roof needs to be cut back to provide tree trunks adequate movement in the wind without pushing on the porch roof.

Front porch roof. Birch tree trunks in contact with roof framing.

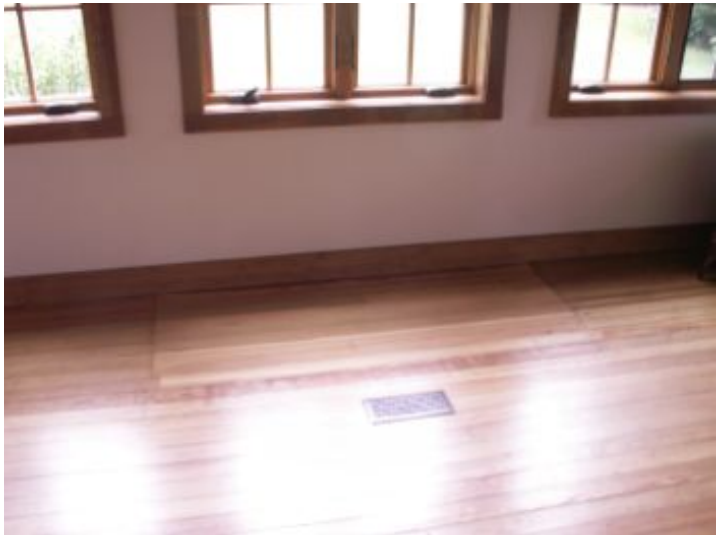
Location of old fireplace. Chimney still on roof.

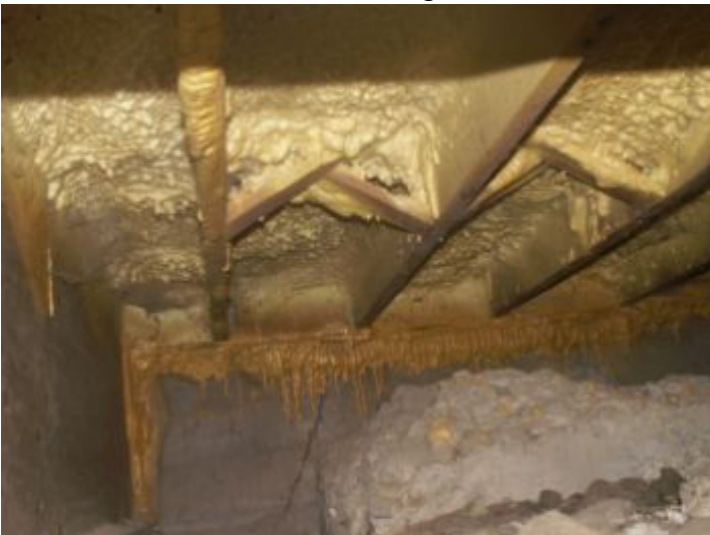
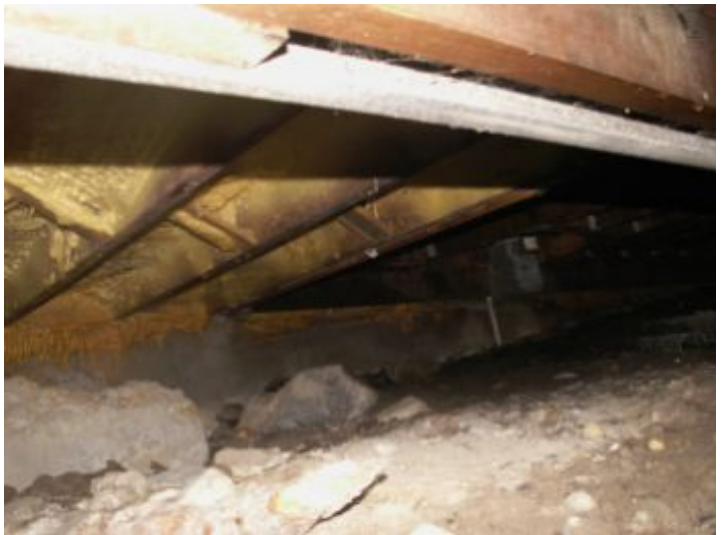
Spray foam insulation below dining room. No deficiencies observed.

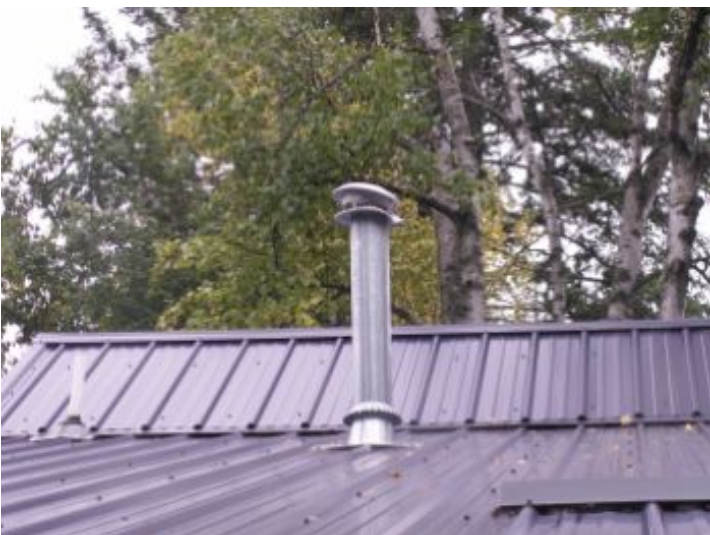
Observations:
• It appears the furnace vent has been hit by a limb. Cosmetic issue.

Furnace vent appears to have been hit with a tree branch. Cosmetic issue.

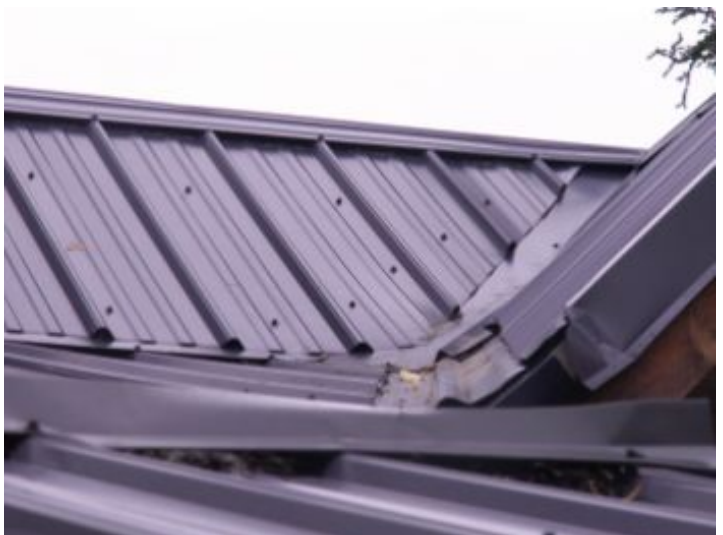
Snow stop is damaged but functioning. Cosmetic issue.

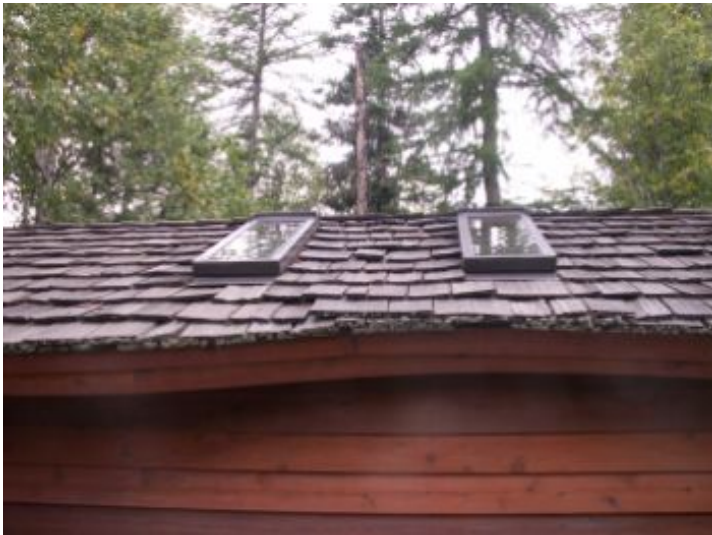
Moss growing on edge of cedar shakes. Cosmetic issue.

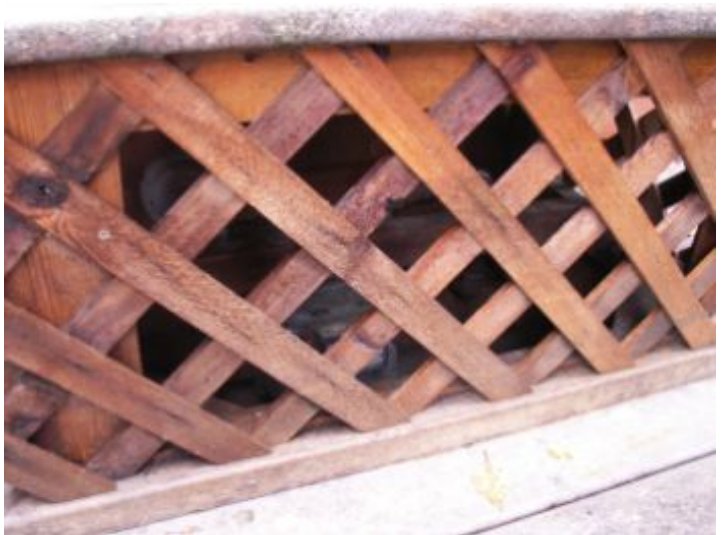
Location of gas meter. Below rear deck.

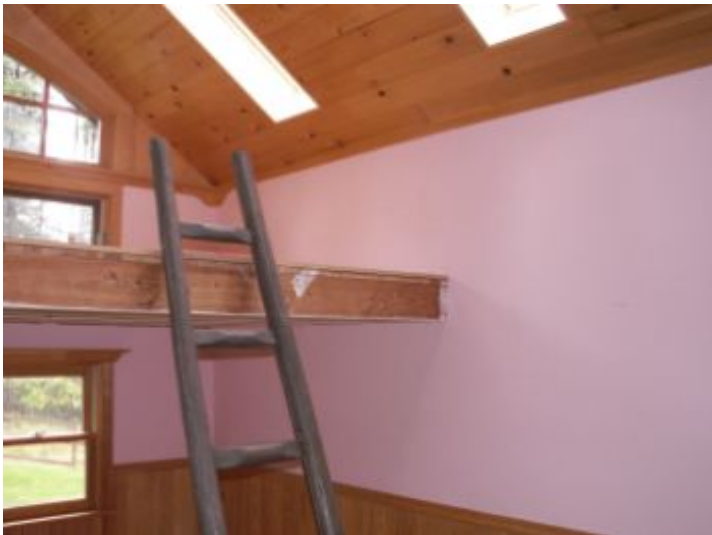
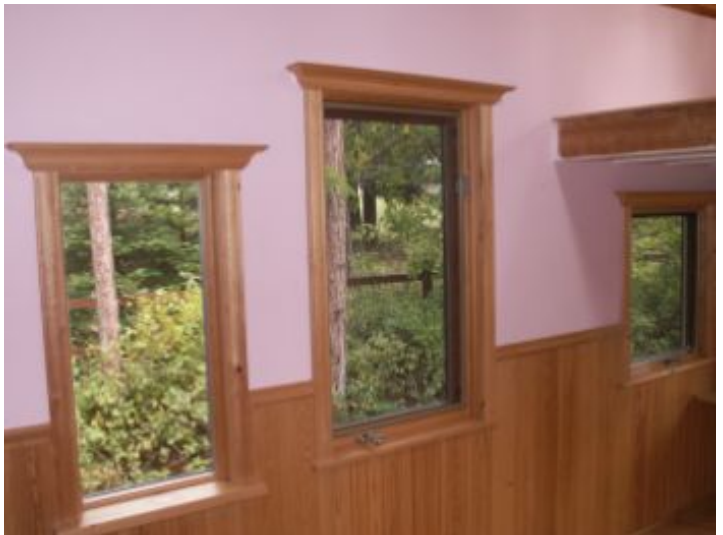
Interior of bunkhouse. No deficiencies observed.
